## Parking Lots And Tripping Hazards

*Without proper maintenance, wheel stops, manhole covers, and even asphalt pose threats to pedestrians.*

*Peter Townsend, P.E. Rimkus Consulting Group*

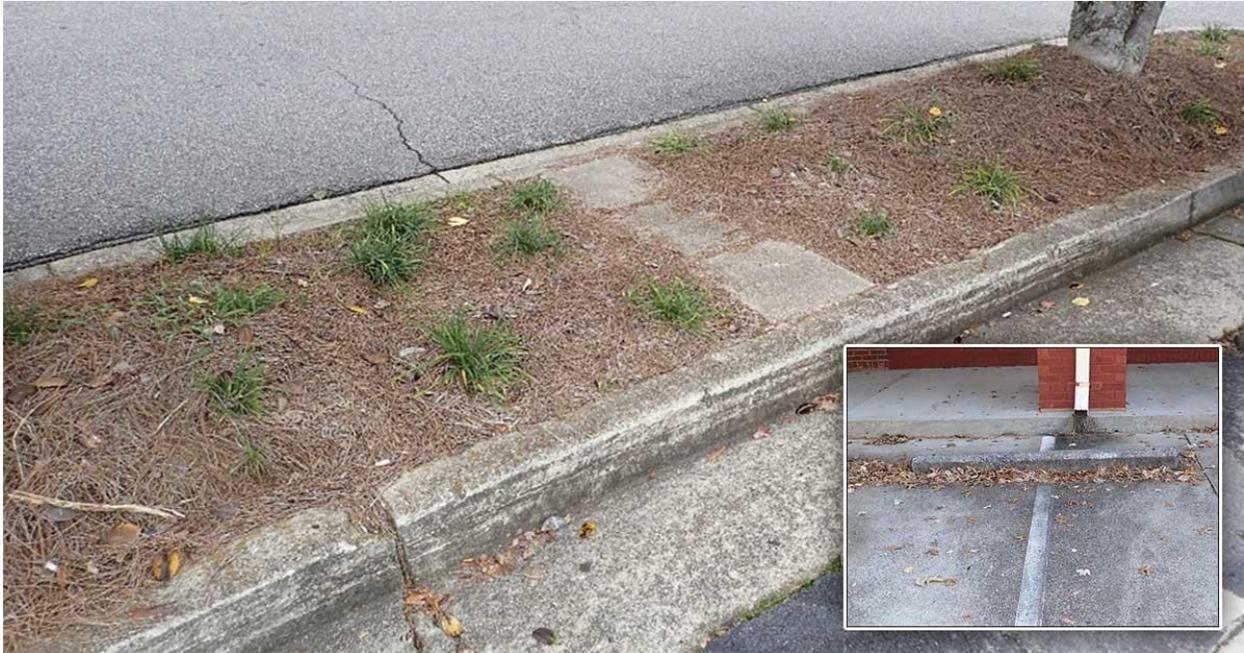
Pedestrian travel across parking islands that were not designed as walkways should be discouraged. Wheel stops (inset) create abrupt vertical changes in the pavement surface, which may not be seen by pedestrians. (Photos: Rimkus Consulting Group)

**Wheel Stops.** These items create abrupt vertical changes in the pavement surface (see inset photo), which may not be seen by a pedestrian if their attention is diverted elsewhere. The prevalence of trip and fall accidents occurring at wheel stops has resulted in some standards recommending that the use of wheel stops be avoided in parking lots. However, wheel stops serve a useful purpose in keeping drivers from pulling too far forward into pedestrian aisles, and, in fact, are recommended for use in the 2010 Americans with Disabilities Act (ADA) Standards for Accessible Design.<sup>2</sup> When used, wheel stops should be installed as follows to minimize the possibility of trip and fall incidents:

**Parking Islands.** Like wheel stops, parking islands help maintain orderly vehicle parking and define the edges of drive lanes. In fact, in many jurisdictions zoning ordinances require the use of parking islands to provide green space. Unfortunately, many pedestrians view parking islands as obstacles to be crossed rather than walking around them. Over time, a trail will develop across the island, where pedestrians may view it as a “short cut”. Maintenance personnel will often attempt to improve the trail by adding walkway pavers over the worn path. Pedestrian travel across parking islands that were not designed as walkways should be discouraged. When it becomes obvious that pedestrians are traveling over parking islands, such use should be discouraged by planting shrubs or groundcover.
